ACCIDENT AT MARKHAM COLLIERY DERBYSHIRE

On the cause of, and circumstances attending,
the overwind which occurred at Markham Colliery, Derbyshire,
on 30 July 1973

J. W. CALDER, C.B., O.B.E., B.Sc., C.Eng., F.I.Min.E.
H.M. Chief Inspector of Mines and Quarries

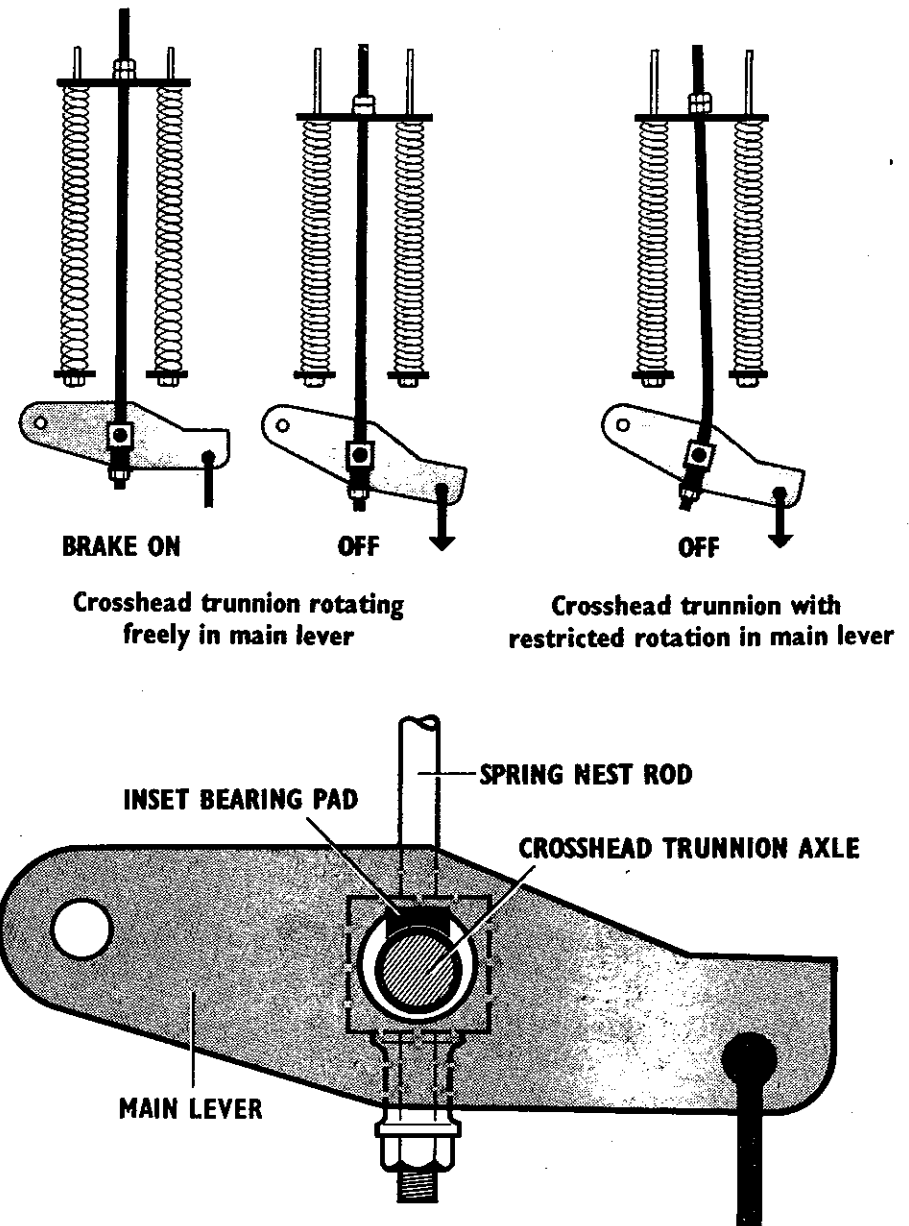
FIG 1
Spring nest centre rod: illustration of bending forces applied.

45. The centre rod appeared to have failed due to fatigue and, therefore, it was decided to investigate the loading and working conditions of a similar rod in service, consequently, the Director of the Safety in Mines Research Establishment was asked to arrange for a technical investigation of the spring nest assembly to be carried out. At the colliery four strain gauges were fitted at 90° to each other on the replacement centre rod as near as possible to the position where the fracture occurred in the original rod. With the winding engine drum stationary, the strains on the surface of the rod were measured with the brake off, when it was applied manually, then automatically and when power was applied to the drum with the brake on. The results of these tests showed that, in addition to the expected direct tensile stresses at the gauge positions, there were substantial stresses due to bending when the brake was operated. On the gauges at right angles to the winding drum shaft the magnitude of the stresses varied to such an extent that on the one furthest from the drum there was a change from tension to compression as the brake was released. Because the origin of these bending effects was not established the complete spring nest

46. In the laboratory the complete spring nest assembly was installed in a test rig and tests were made which accurately simulated operation of the brake. These confirmed that bending was the cause of the alternating stresses in the centre rod. Significant stresses were induced by bending in the lower part of the rod because the main lever was unable to rotate freely about the crosshead trunnion due to excessive friction between the trunnion axles and the bearing surfaces in the main lever (Fig. 1). It was found that if friction at the crosshead trunnion was relieved by forcibly separating the bearing surfaces and inserting lubricant the stresses in the rod caused by bending were significantly reduced. However, after a few operations the lubricant was forced out by the high bearing pressure.

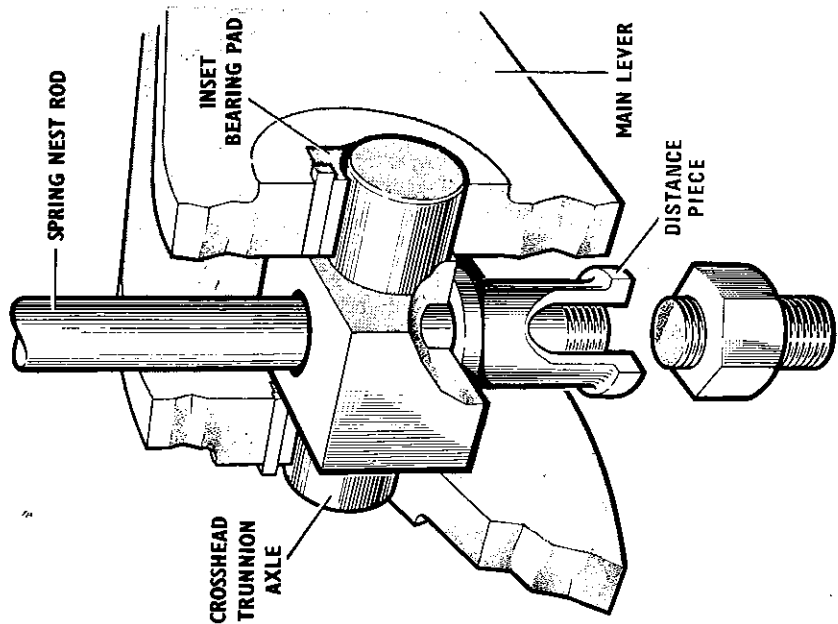
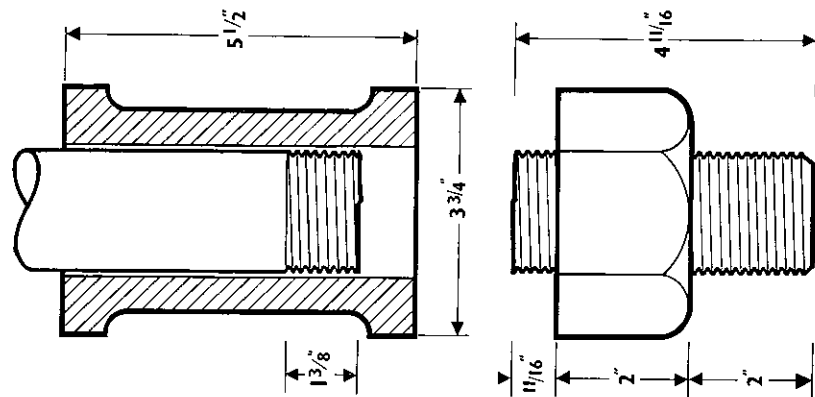
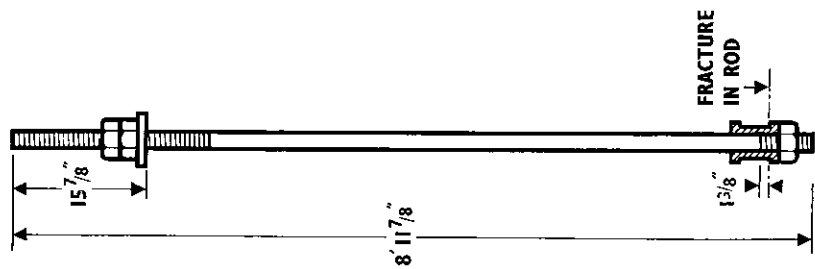
FIG 2
Spring nest centre rod and trunnion detail.

47. Metallurgical examination of the spring nest rod showed that it had failed because of fatigue, where it passed through the distance piece, at a thread $4\frac{3}{4}$ inches from the bottom end (Fig. 2). There was evidence that three small cracks had existed for some time at this thread and that one of these had propagated to a depth of 1.1 inches before the rod broke (Plate 4). Numerous additional cracks existed in the threaded portion above and below the fracture (Fig. 3). Although small cracks, present in the region of the fracture, were found in the laboratory by the magnetic particle method of non-destructive testing, experiments showed that they would not have been revealed by applying an ultrasonic probe to the top end of the rod while it was installed in the spring nest. However, a saw cut representing a crack which had penetrated the rod to a depth of $\frac{2}{3}$ inch, was detected by an ultrasonic test.

49. The broken rod was made from 0.4 per cent carbon steel of good commercial quality with an ultimate tensile strength of 38 tonf/in² and the mean tensile stress induced by the spring nest at the minimum cross section was 6.2 tonf/in². Consequently, the static factor of safety was 6.1. However, because of bending, alternating stresses with an amplitude of ± 6.6 tonf/in² were superimposed on the tensile stress. This is far in excess of an appropriate working value of ± 3.6 tonf/in² for this type of threaded rod as quoted by Dr. Heywood in his book *Designing Against Fatigue*. On this basis failure of the rod was inevitable.

* 62. Evidence given at the Inquiry showed that the trunnion bearing did not operate as designed and caused fluctuating stresses to be induced in the centre rod of the spring nest which it could not sustain. R. Jeffrey, Senior Scientific Officer, Safety in Mines Research Establishment, said that any crack which had penetrated to a depth of $\frac{3}{8}$ inch could have been detected by ultrasonic tests without removing the rod, but not by visual examination with the unaided eye. There is uncertainty as to the frequency of ultrasonic testing which would have been necessary to discover the main pre-existing crack as its rate of propagation beyond $\frac{3}{8}$ inch could not be established. It appears that the persons at the colliery having responsibility for maintenance had no reason to suspect that the rod was overstressed and, therefore, did not appreciate the need for special methods of testing. Nevertheless, the rod was shown to be of inadequate strength for the stresses induced and the main pre-existing crack could have been found by available means of testing. Also, there was a precedent for this type of failure in a similar rod at Ollerton Colliery in 1961.

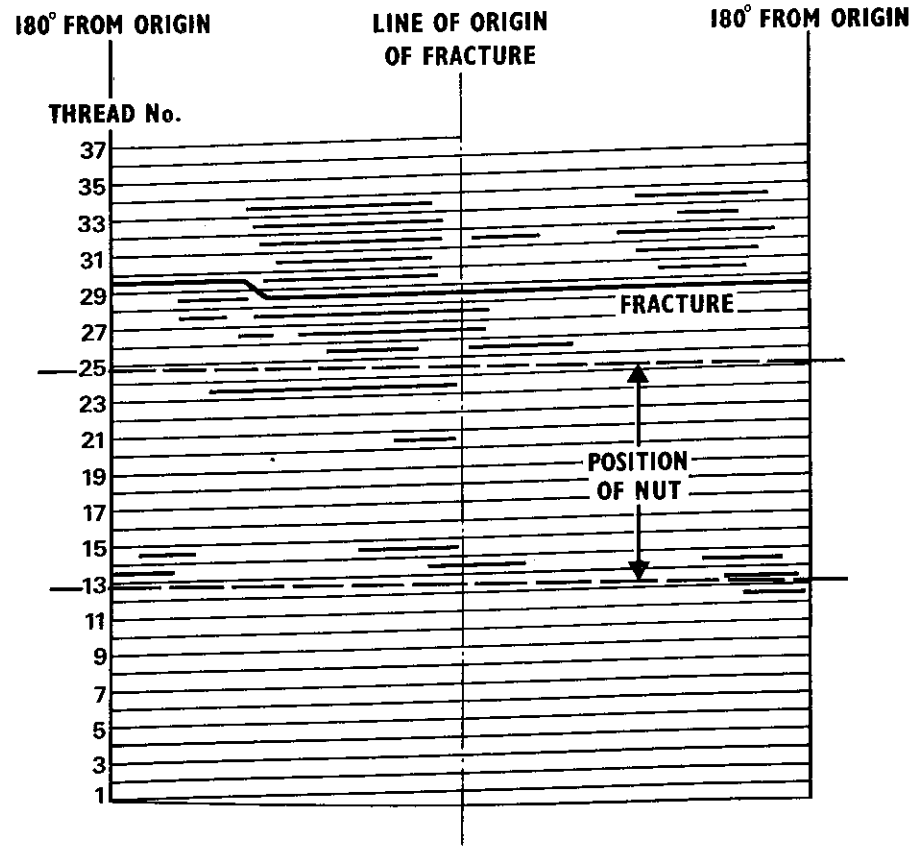
FIG 3
Cracks adjacent to fracture.

56. Laboratory tests on the Markham rod by the magnetic particle method revealed cracks of various dimensions in thread roots on each side of the fracture. Ultrasonic tests, which can be carried out *in situ*, did not detect these cracks but could have detected one $\frac{3}{8}$ inch or more in depth. The probability of detecting the crack which led to failure by the ultrasonic method would, therefore, have depended on its rate of propagation and the interval between tests.

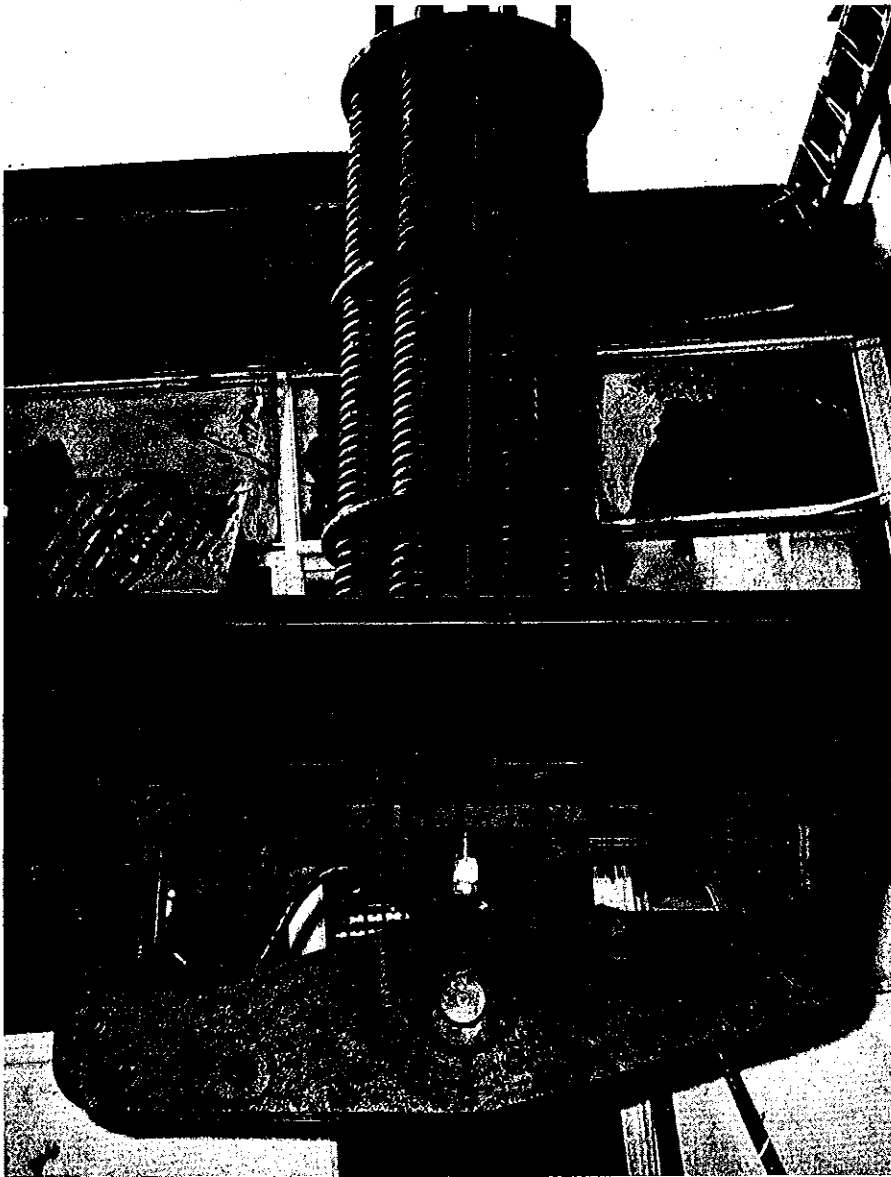
PLATE III
Brake engine after removal.

assembly was sent to the Safety in Mines Research Establishment for further investigation (Plate 3).

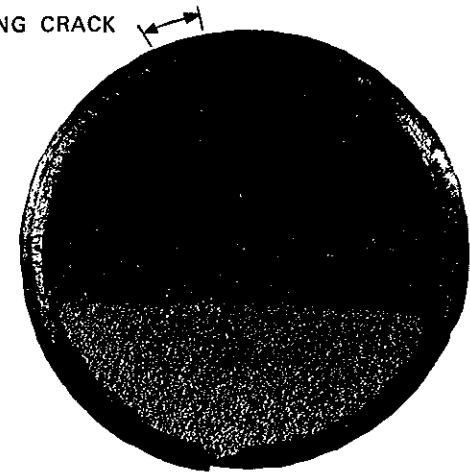
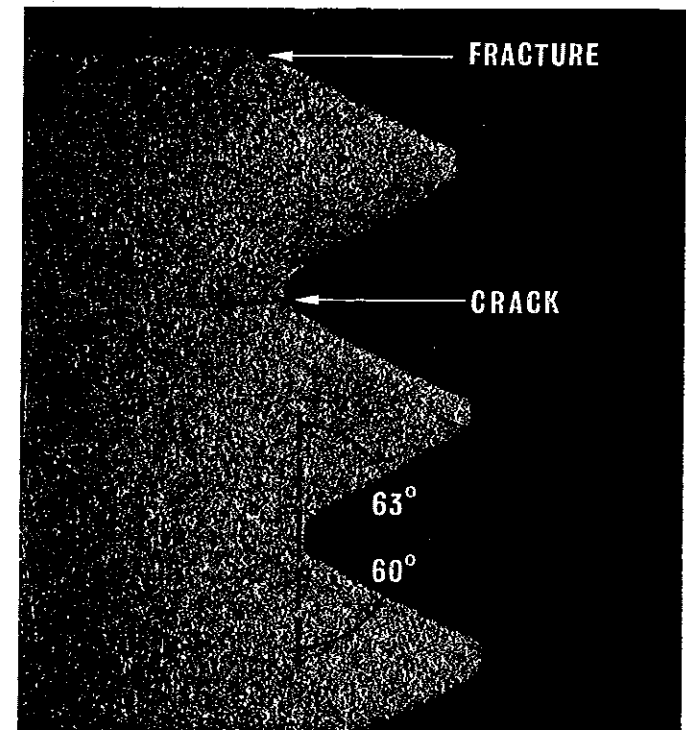
PLATE IV
Characteristics of fracture and thread form.
(Magnification factor of illustrations:
Top - X 1.15, bottom - X 7.00).

PRE-EXISTING CRACK

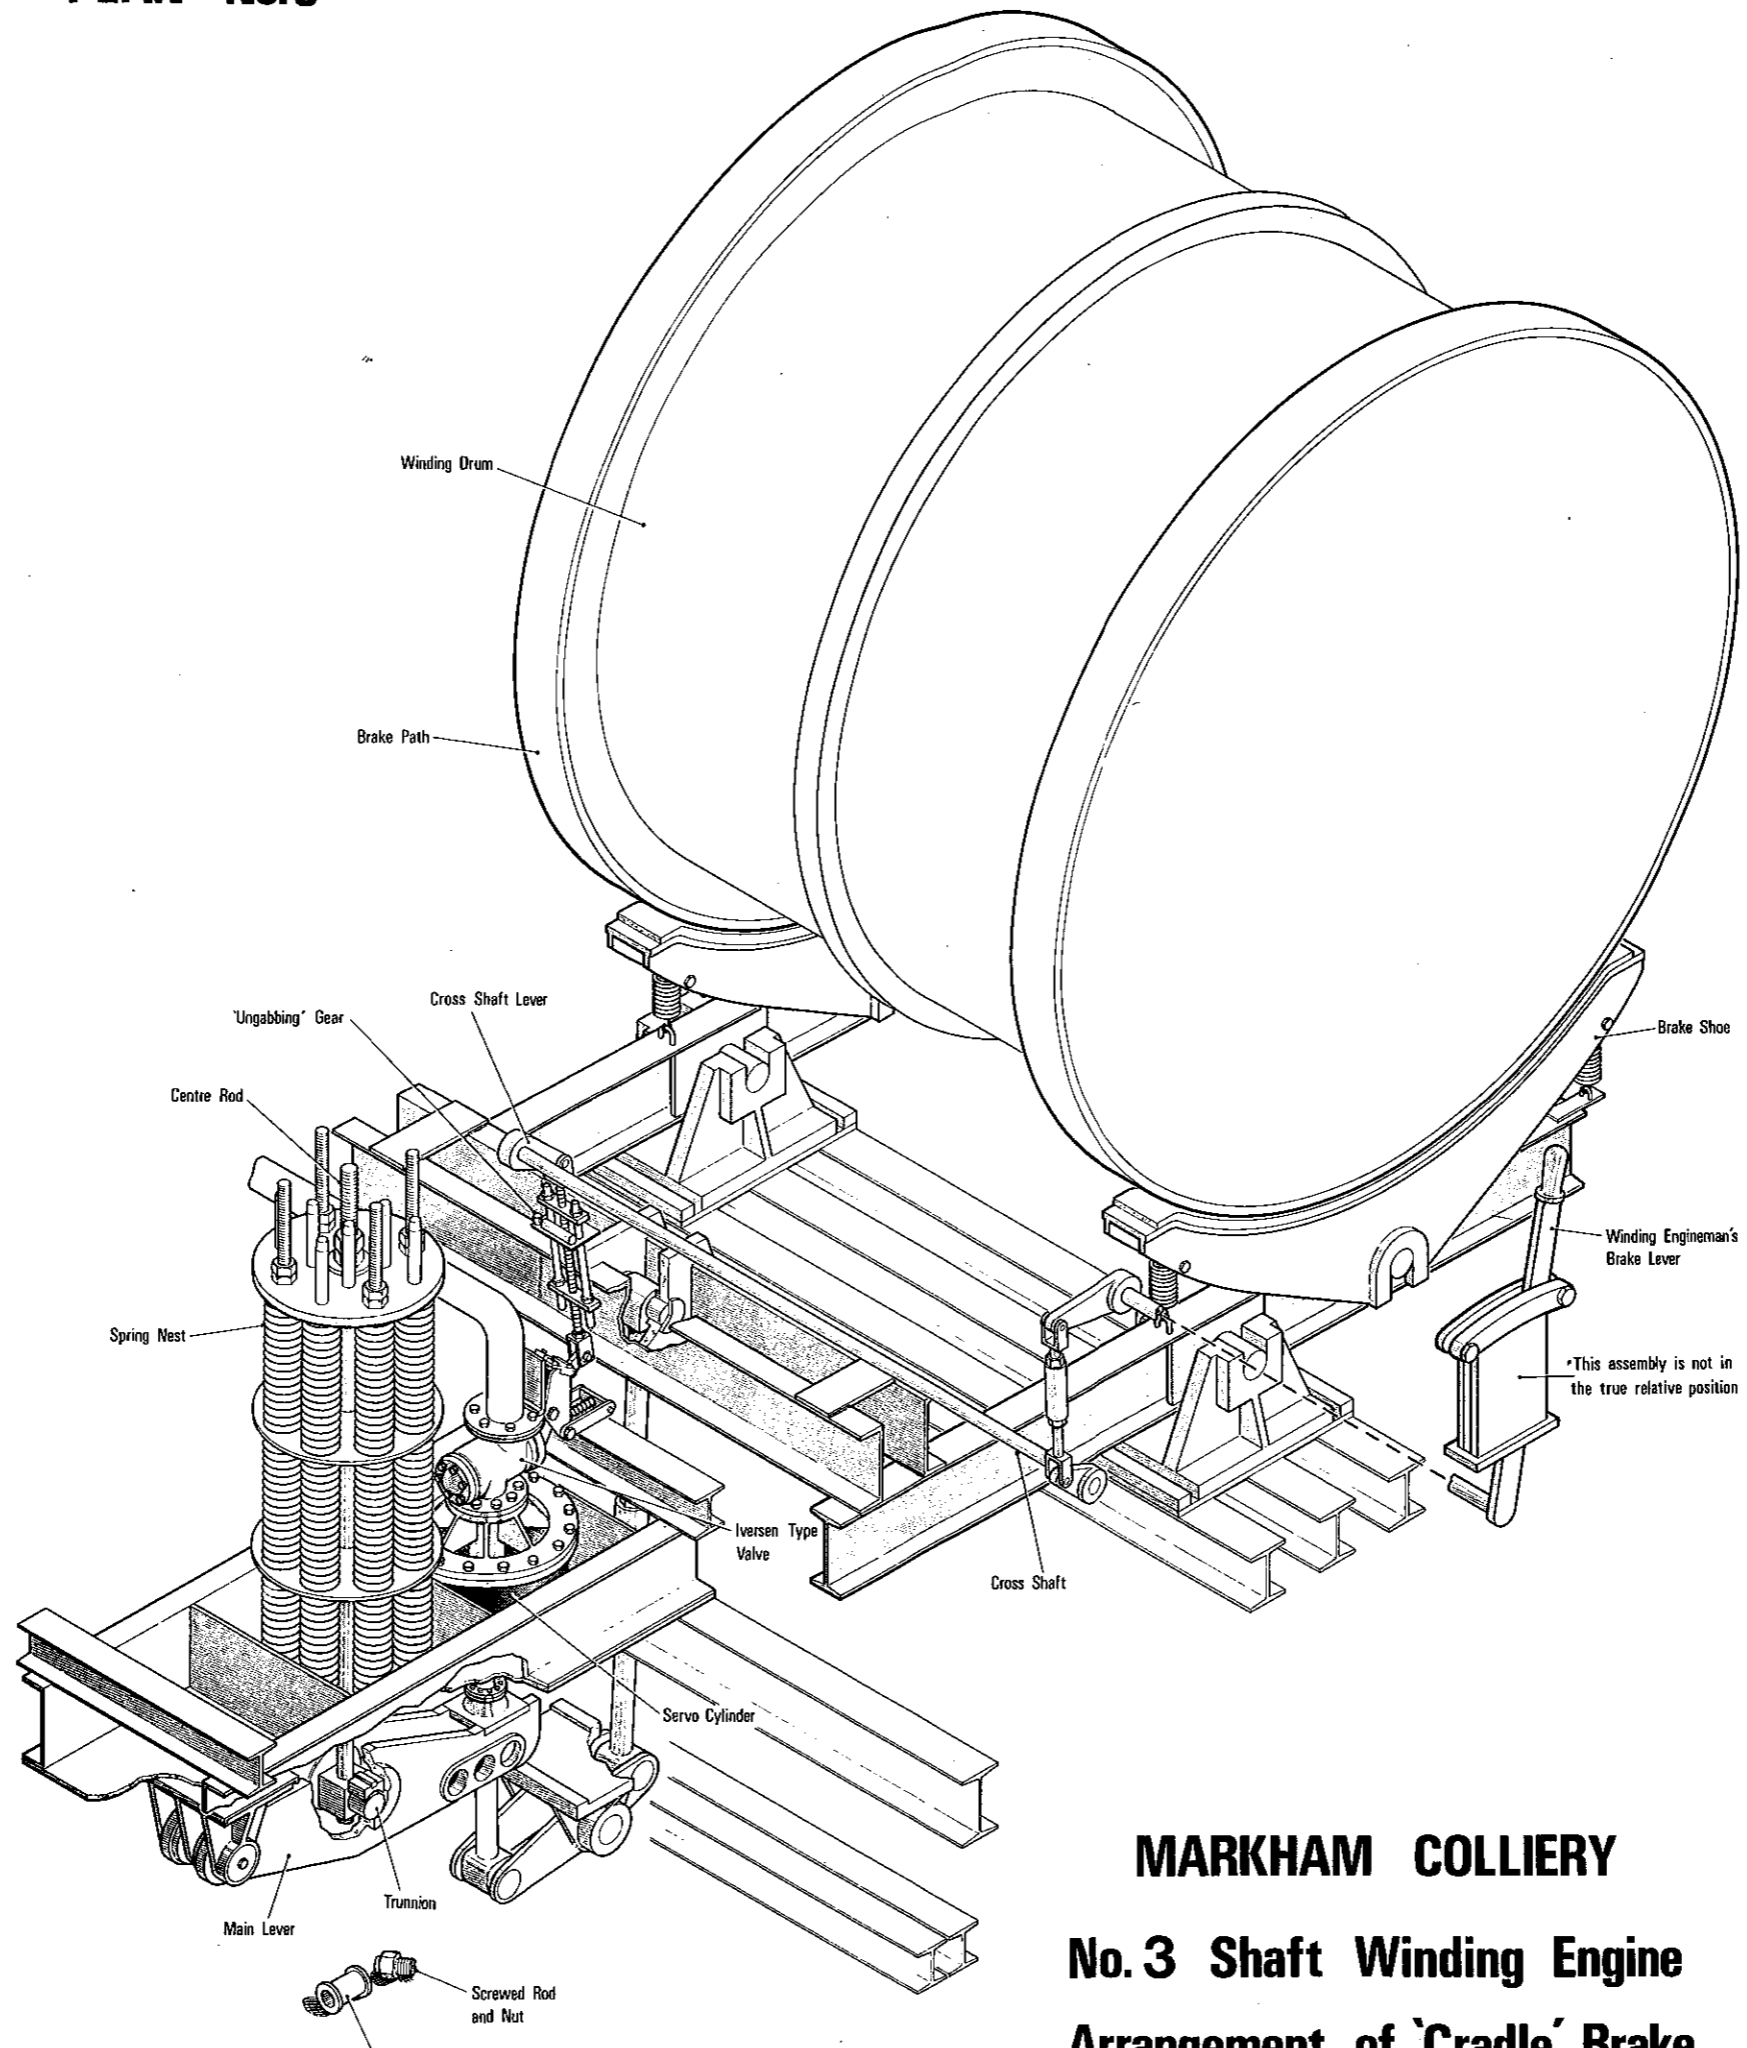
PLAN No.5

23. At the time of the accident a Burns Cradle type brake was in use (Plan No. 5). It consisted of a pair of Ferodo lined brake shoes applied to the underside of the brake paths by the action of the compressed spring nest operating through a system of levers. The brake was released by using compressed air to counteract the force of the spring nest and move the brake shoes away from the drum brake path. During normal braking the winding engineman's brake lever operated an Iversen type valve which controlled the flow of compressed air to a servo-cylinder.

de-energised and the 'ungabbing' gear immediately disengaged the engineman's brake control lever from the Iversen type valve and caused the mechanical brake to be applied (Plan No. 5). The 'ungabbing' gear could not be reset until the brake control lever was returned to the 'brakes on' position and the safety circuits were energised.

52. After completion of the investigation the winding engine was re-assembled with new spring applied caliper type brakes and a high pressure hydraulic system having duplicate brake solenoids, all supplied by Blacks Equipment Limited. The drum sides were replaced, barrel plates renewed, and a tachogenerator installed to operate the rope speed indicator. A reconditioned automatic contrivance was installed with an independent drive. Commissioning tests were carried out for the previous winding duties and, in addition, it was demonstrated that the winding system could be brought safely to rest by braking on only one brake path. The representatives of the interested parties agreed that normal winding could be resumed on 1 October 1973.
